WILLYS MOTORS, INC.

Service Bulletin

K-W No. 233

HEADLINING BOWS

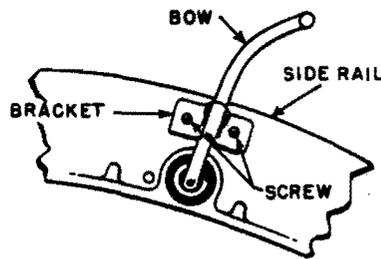
FIG. 2

A headlining bow allowed to move from its properly installed position may result in a loose or sagging headlining.

1. Make brackets as shown in Figure 1 from any suitable metal available. One bracket is required for both ends of each bow to be secured in position.
2. Be sure bow ends are correctly installed in the side rail grommets.
3. Adjust the bow to its properly installed position.
4. Slide headlining away from the side rail in the area of the bow end being worked on.
5. Place a bracket over one end of the bow as shown in Figure 2.
6. Drill two 3/16" holes (as indicated in Figure 2) through the bracket and side-rail while holding the bracket in the position shown in Figure 2.
7. Attach the bracket to the side rail with suitable sheet metal screws as shown in Figure 3.
8. Repeat 1 through 7 above until a bracket has been installed on both ends of each bow to be secured in position.
9. Complete headlining installation.
