Service Bulletin

K-W NO. 276

ENGINE
PERFORMANCE

1954 KAISER
MODELS

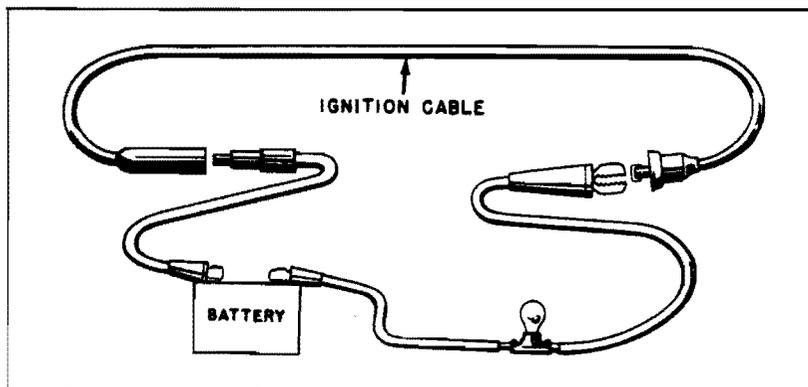
2. To determine if an open condition exists in a cable, test it using a 6 volt battery and a 6 volt lamp. See sketch. If lamp fails to light when the circuit is completed, replace the cable as an open circuit exists.
